Sewall Wetland Consulting, Inc.

RE: Stream Classification Report – Parcel #0924069243
City of Issaquah, Washington
SWC Job #15-110

This report describes our observations, delineation and classification of the stream located on Parcel #0924069243, at 3519 228th Avenue SE in the City of Sammamish, Washington (the “site”).

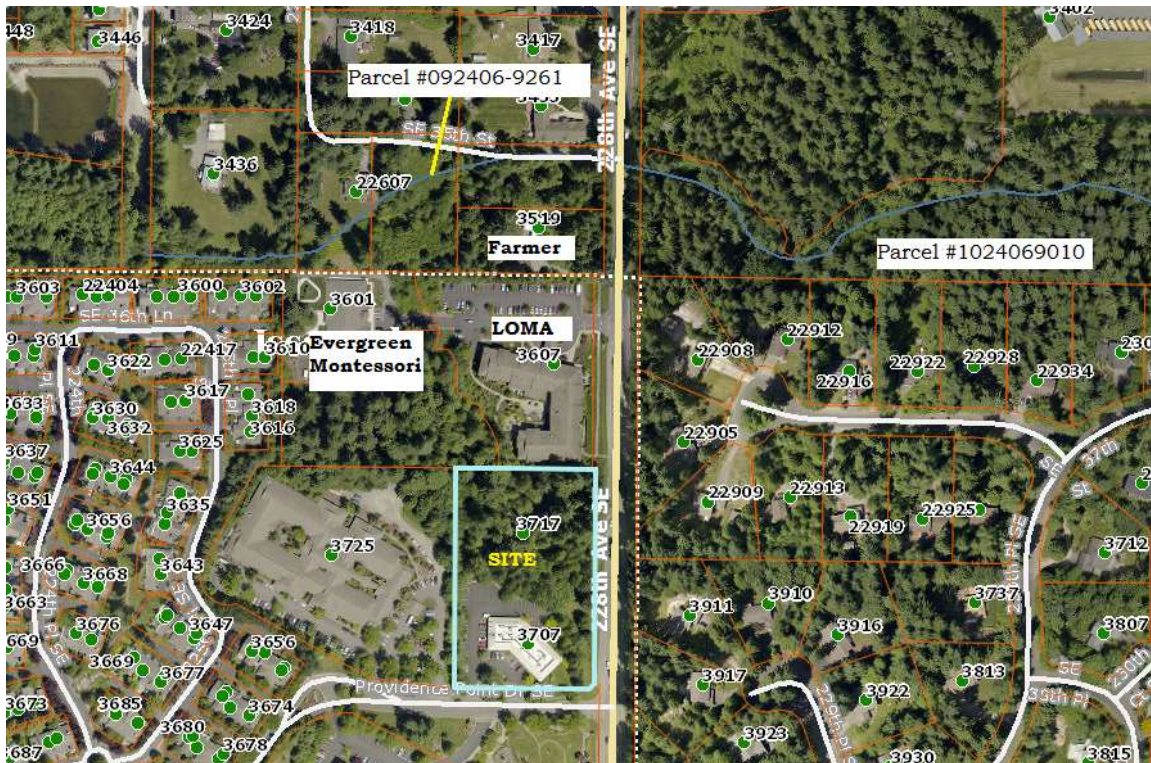
Above: Map of other properties studied

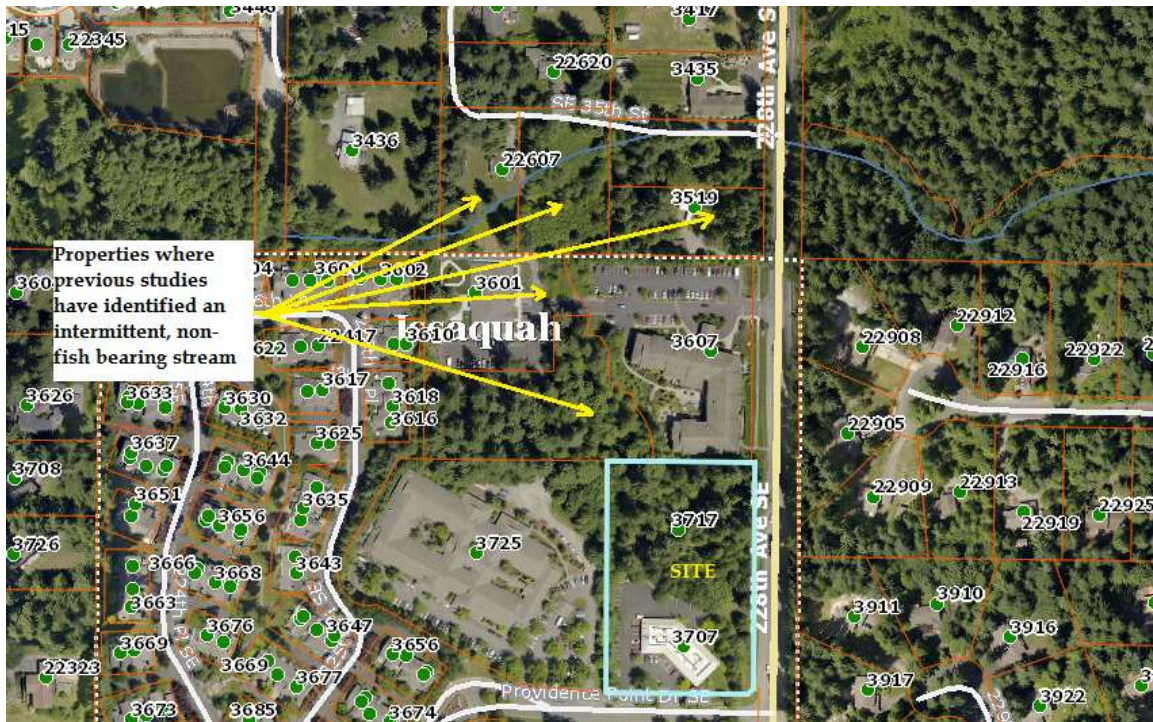
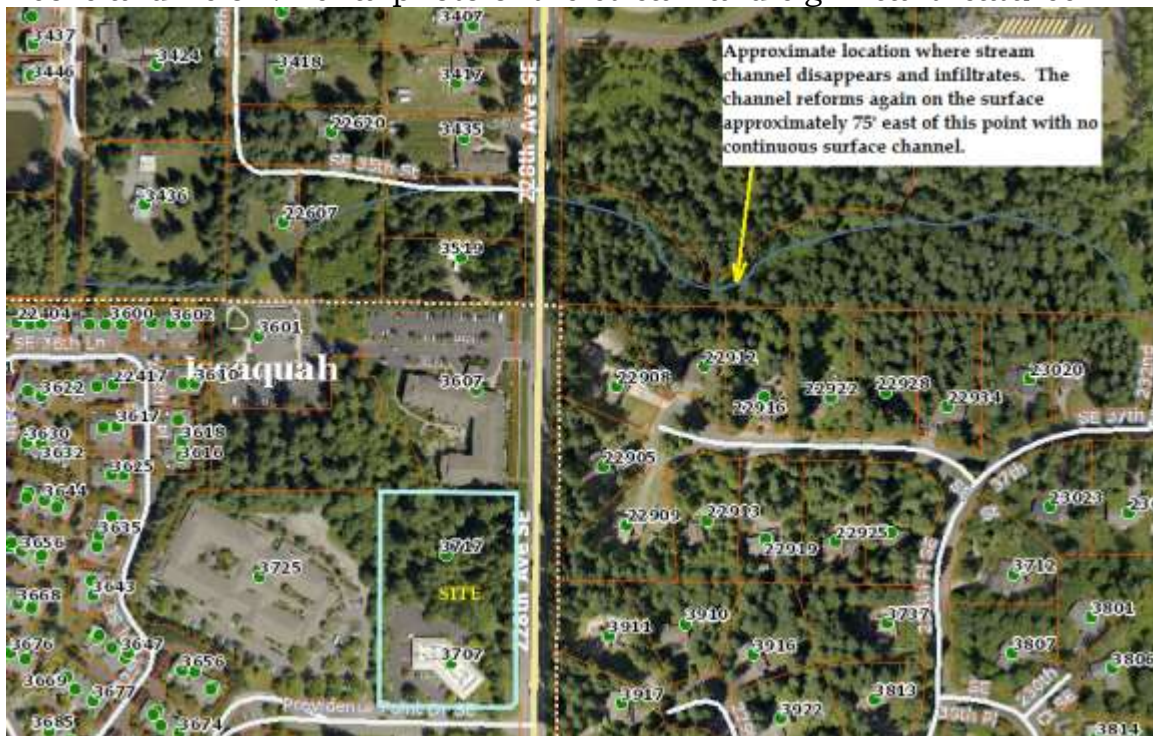
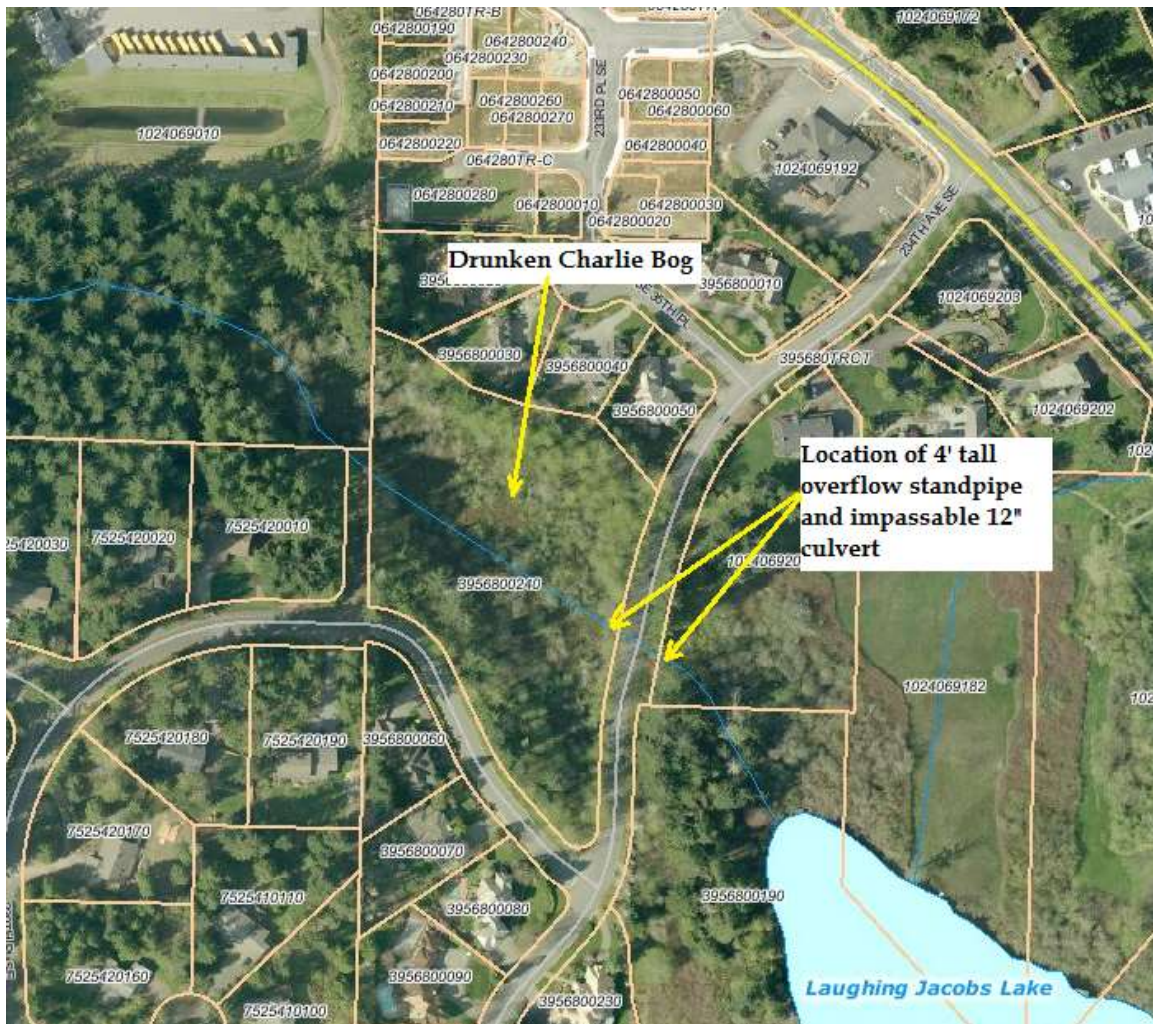
Above and Below: Aerial photo of the stream and significant features

What was found confirms that this stream is a non-fish bearing intermittent stream channel as has been determined in the past. On my site visit 2-3-15, I observed no stream flow on the site. Off-site on the east side of 228th Avenue SE, the channel was also found to be dry, despite fairly heavy recent rainfall. As the channel drains easterly through the forested area, the channel is dispersed and poorly defined, with apparent sheet flow when flow is present.

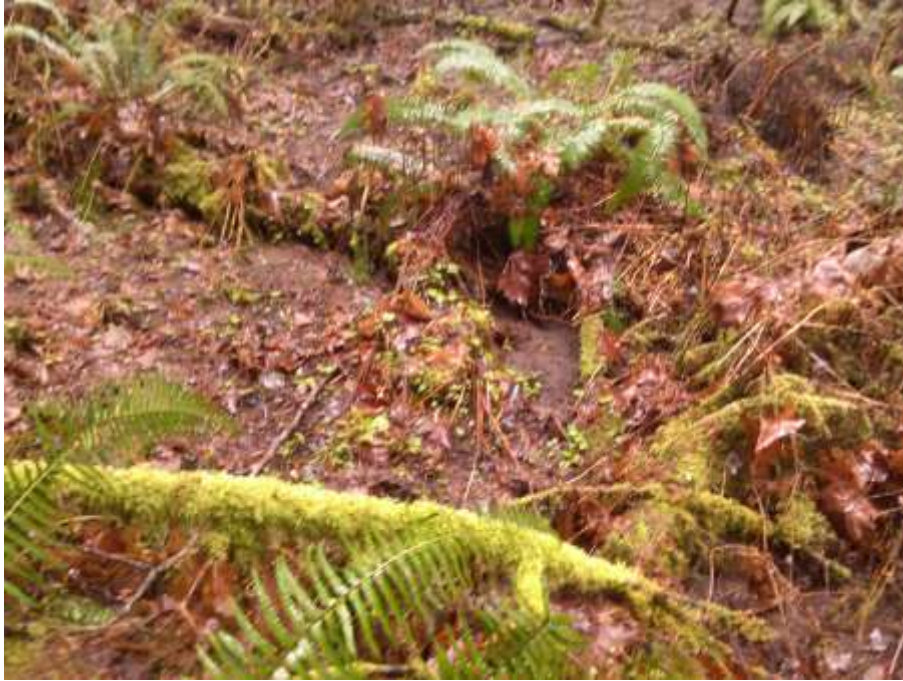
*Above: Stream channel several hundred feet east of 228th and downstream of the site. Note area appears to sheet flow with no well-defined channel.
Below: point approximately 500' east of 228th where water infiltrates and channel disappears.*

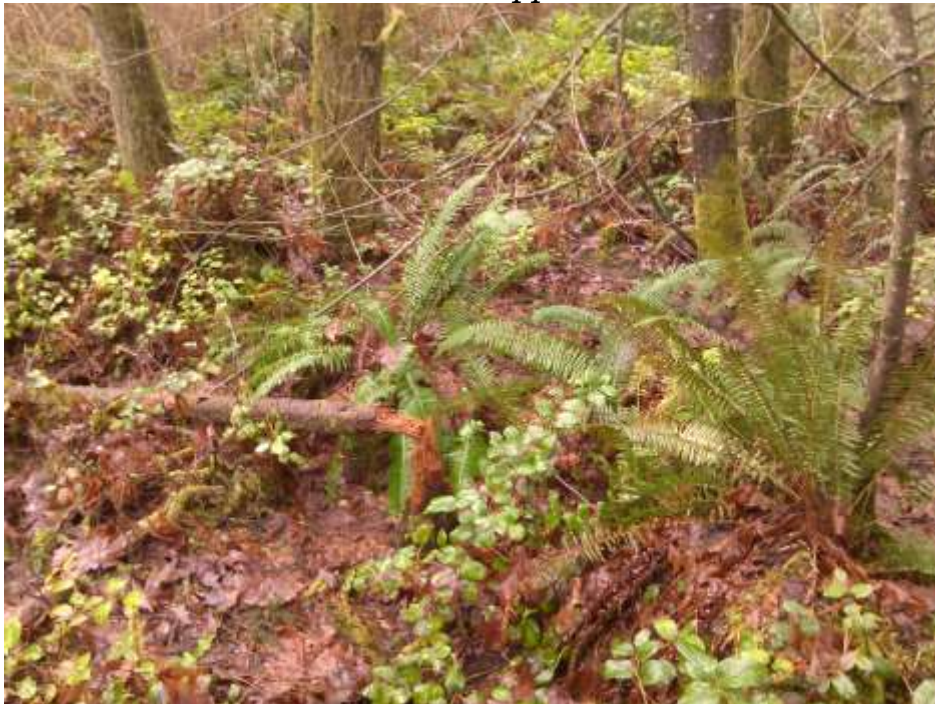
At a point approximately 500 feet easterly of 228th the stream channel disappears completely, appearing to infiltrate into the ground. I proceeded approximately 75'-100' further east with no evident channel present. At a point approximately 100' east of the end of the channel, wetland starts to emerge which appears to be the west end of the wetland known as Drunken Charlie Bog. Drunken Charlie Bog is located west of 234th Avenue SE.

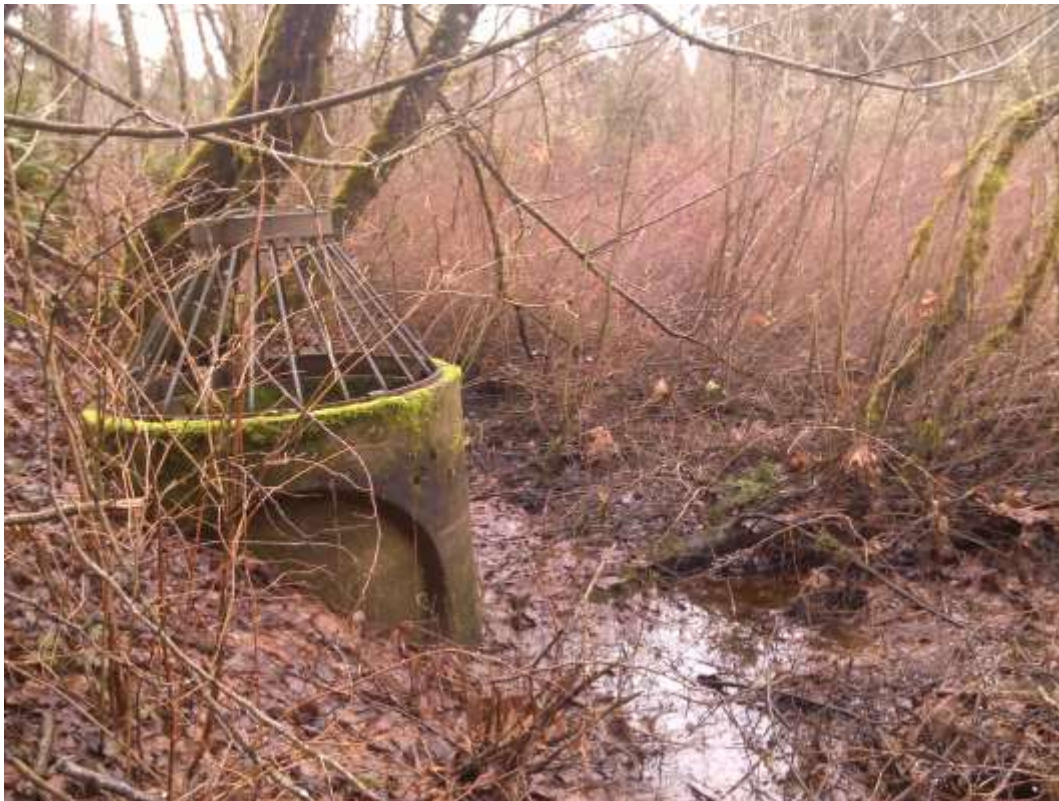
Drunken Charlie Bog is the eventual receiver of water from the stream on the site. This water sheet flows out into the bog with no defined channel through the wetland. This wetland contains a large overflow pipe at its east end, as well as a small (12") concrete pipe which pass under 234th and into the wetlands bordering Laughing Jacobs Lake. The 12" pipe is open on the west side of the road, but buried under rock on the east side.

Standpipe on west side of 134th in Dunken Charlie bog.

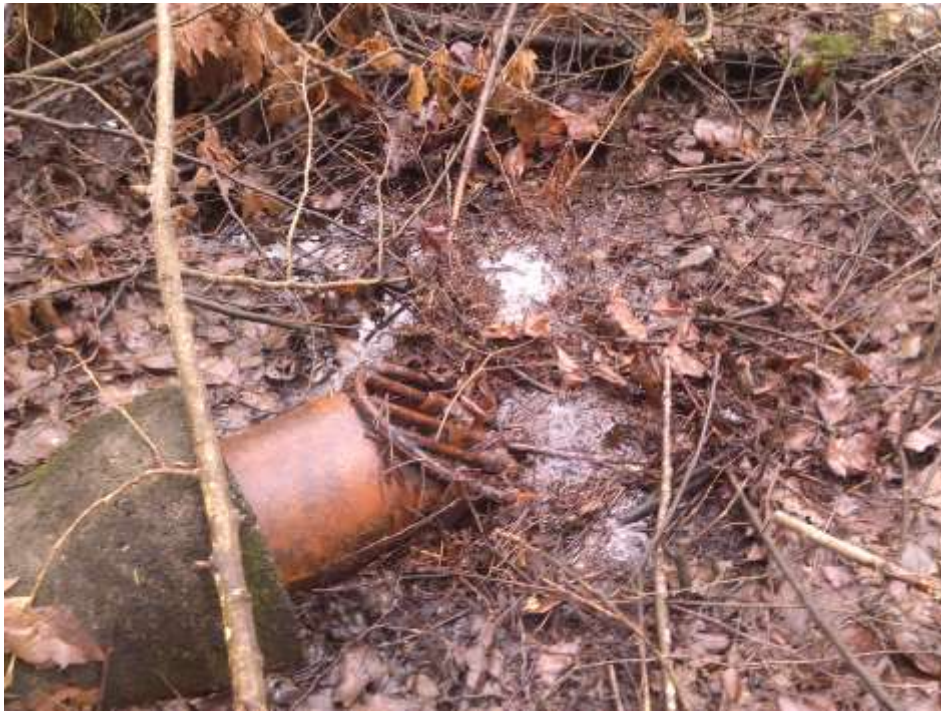
*Above: 12" pipe that passes under 234th from Dunken Charlie bog.
Below: Outlet on east side of 234th.*
